The Belvedere Condominiums

Rehabilitation

2016

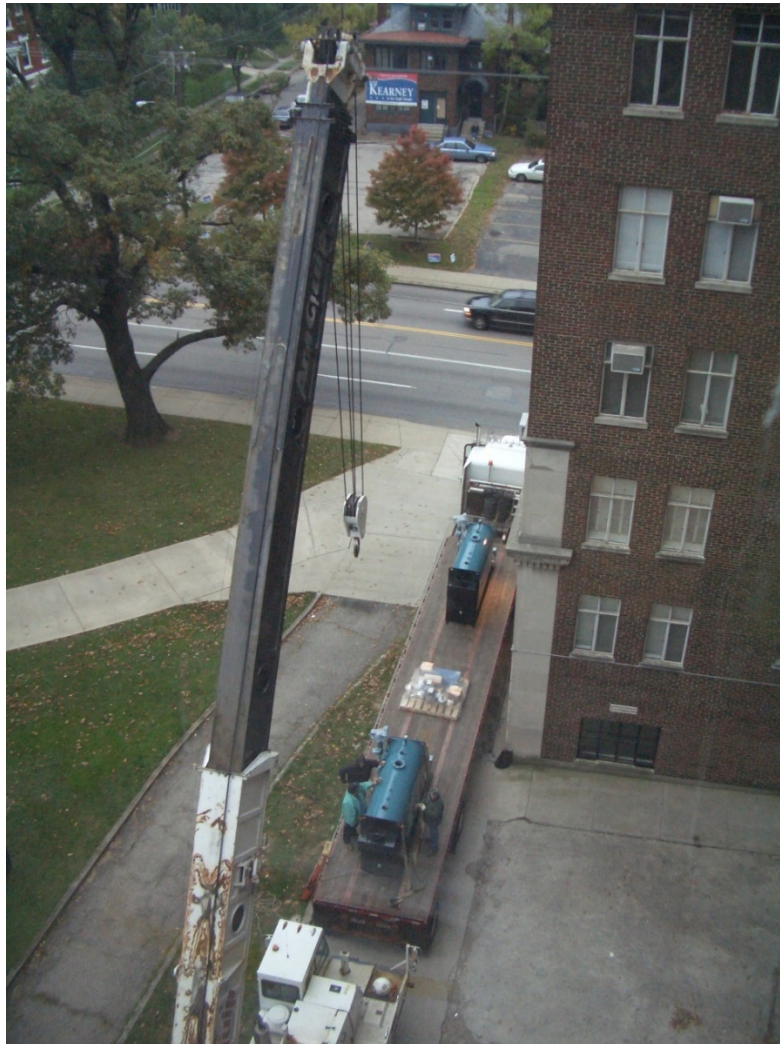
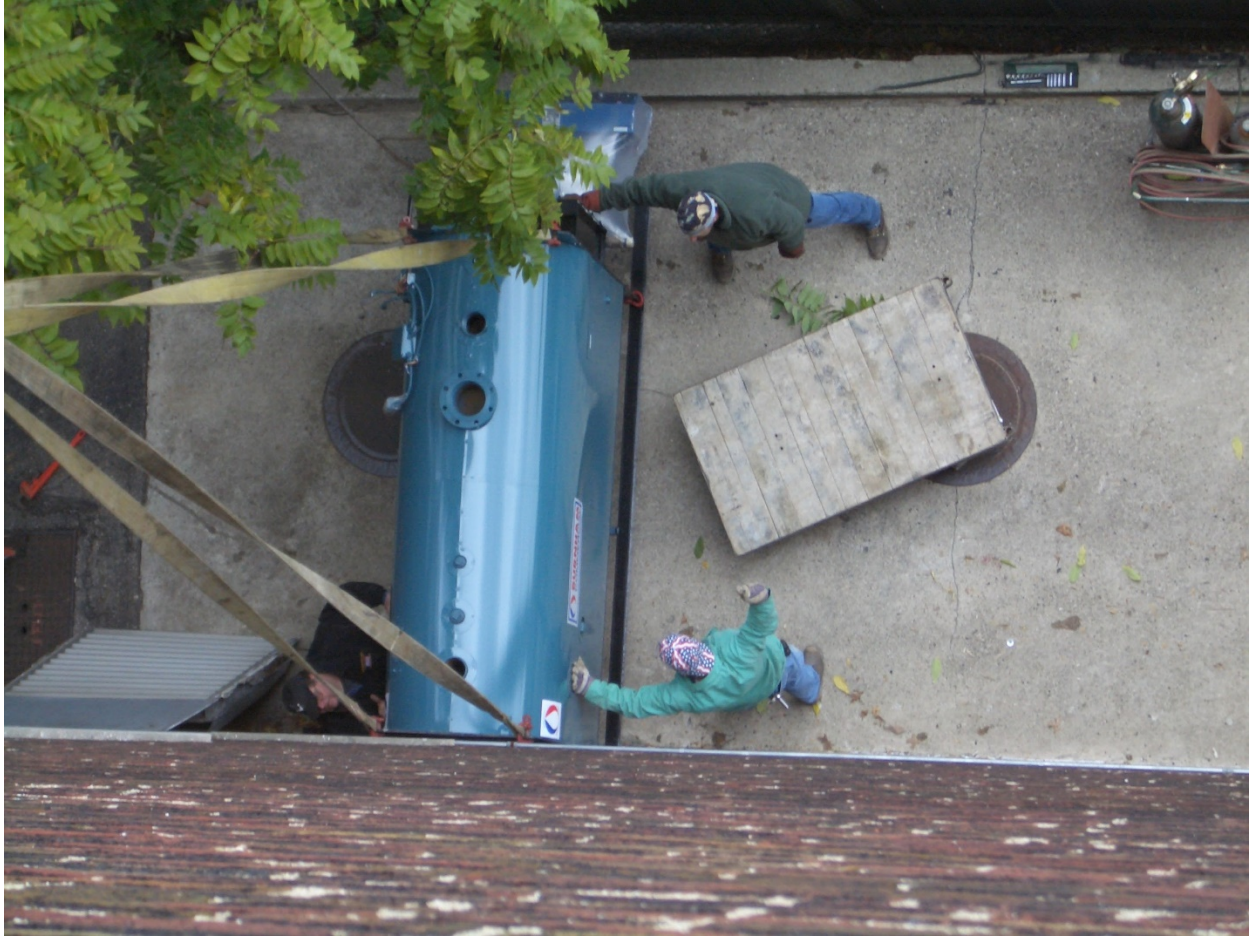
A new boiler gets maneuvered into the boiler room

The old boilers were very quiet but also very inefficient by today's standards. Two new, much smaller units were enough to replace three big old cast iron giants.

There were initial problems with noise mitigation, and those proved difficult to solve, but they were solved eventually.

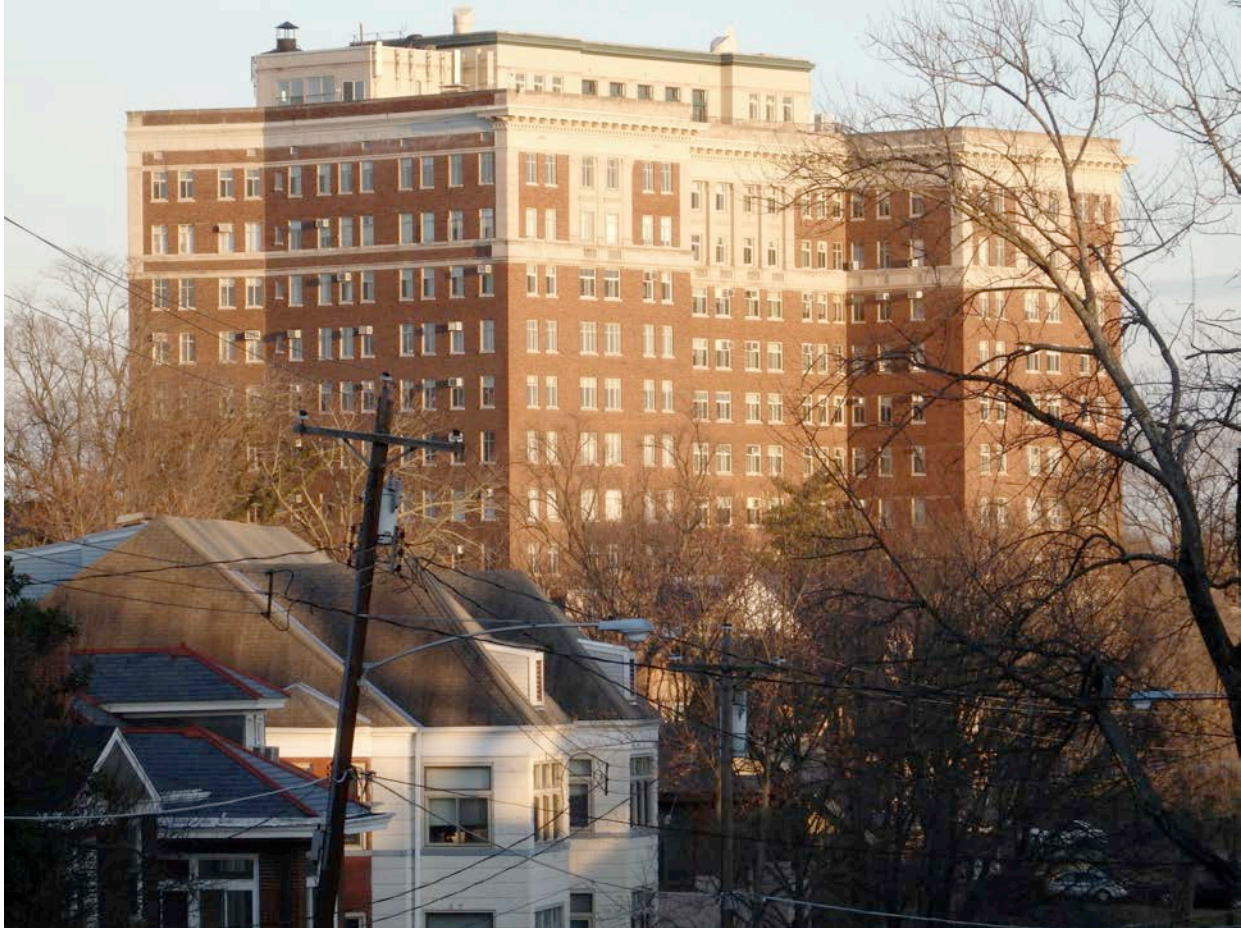
The Belvedere had all its terribly inefficient, original, single-pane steel frame windows until about 10 years ago. The owners' association had never managed to unite to get all of them replaced, even though many of the windows were in bad condition, and sometimes showered the sidewalks with broken glass in high wind weather. Too many owners were opposed because of the project's high cost – the building has about 1,000 windows.

The new windows could not keep the exact proportions of the original windows, but they come close: this 2016 picture shows old and new windows side by side. If you know they are there, you can kind of pick them out, but otherwise you would never know.

But a new window type (commercial grade triple pane vinyl) was finally selected and approved, under the condition that owners could replace their windows on their own schedule.

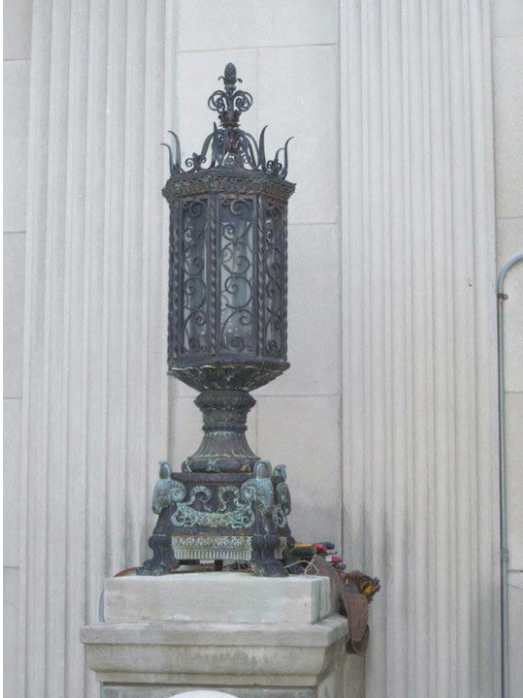
Before

The four magnificent carriage lanterns flanking the building entrance were deinstalled, cleaned, stripped and repainted:

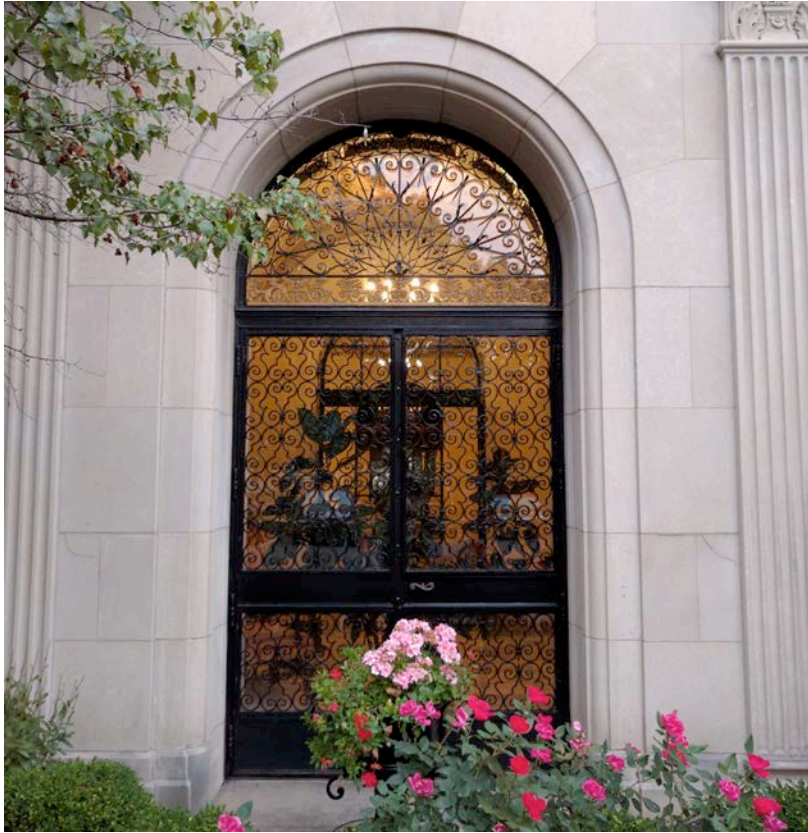
The repaired door today:

2010 picture showing deterioration of the door's bottom. The door is inoperable. Other doors were also repaired, but this repair was the most difficult one. The doors had to be taken apart completely, fixed, and reassembled at the end.

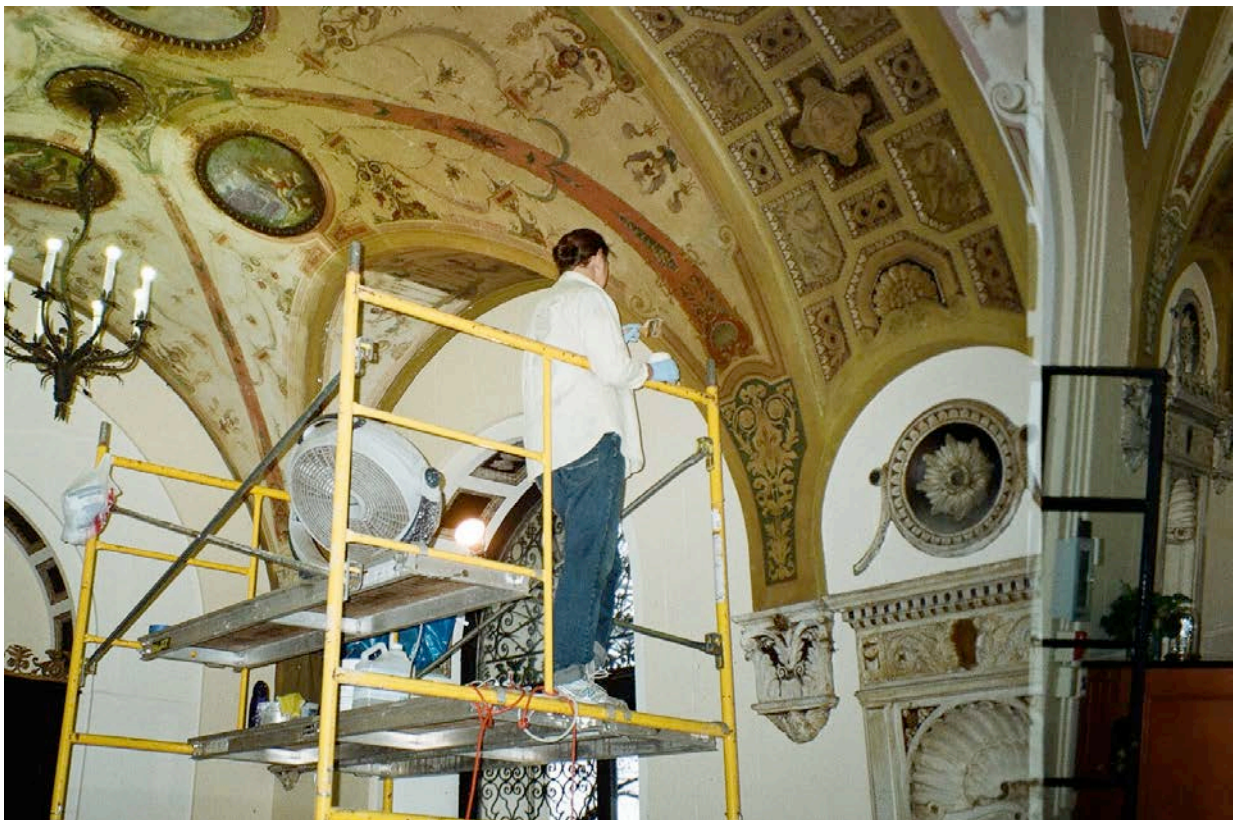
The canvas and colors have had a lot to deal with over the years. The canvas needs minor fixes every few years, but the last major restoration was more thorough, not only cleaning and reattaching the canvas, but also the coloring of the wall details.

Kristen Lemon restores the canvas, 2011. Note the cleaned area on the left.

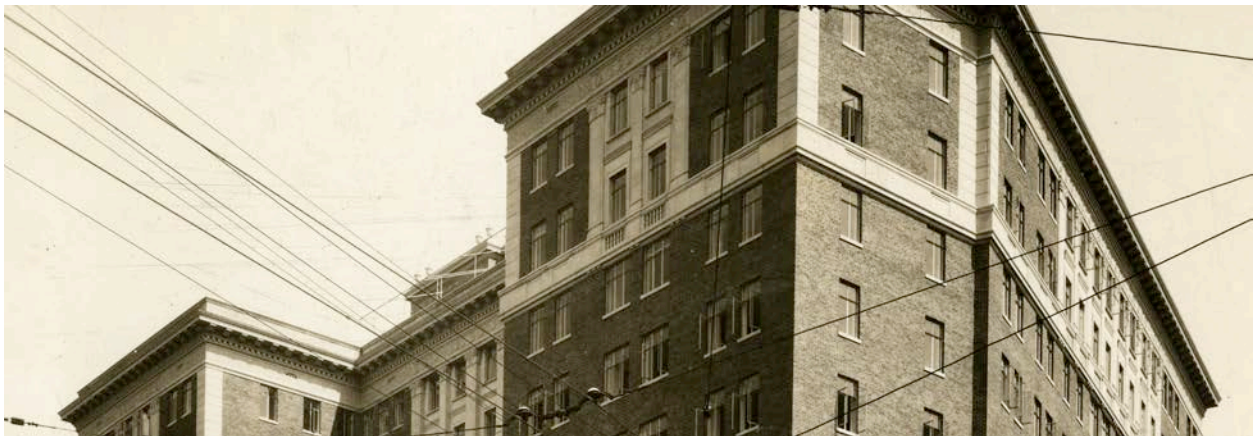
The Belvedere was originally built with 8 ornamental metal urns on top of the roof. Over time, 6 of them were removed for reasons unknown – were they a safety hazard, or too hard to keep clean, or just considered unnecessary?

A picture from the late 1920s, with all the urns

When one of the urns was rediscovered in storage, the board decided to make enough copies of it to replace the lost ones. As a side benefit it was discovered that previously mysterious problems with water leakage could be traced to the places where the old urns had been missing. Without the urns on top of their bases, the fastening holes created weak points in the roof.

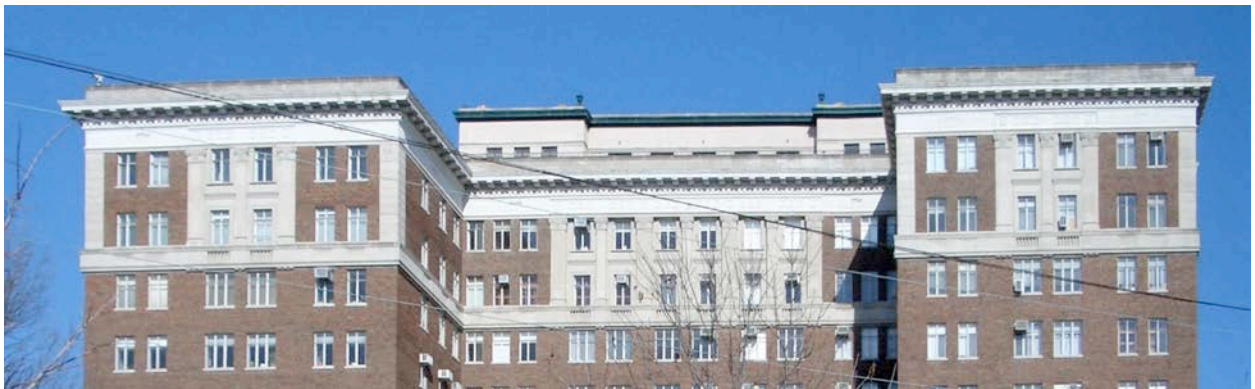
In 2005, only two urns remained

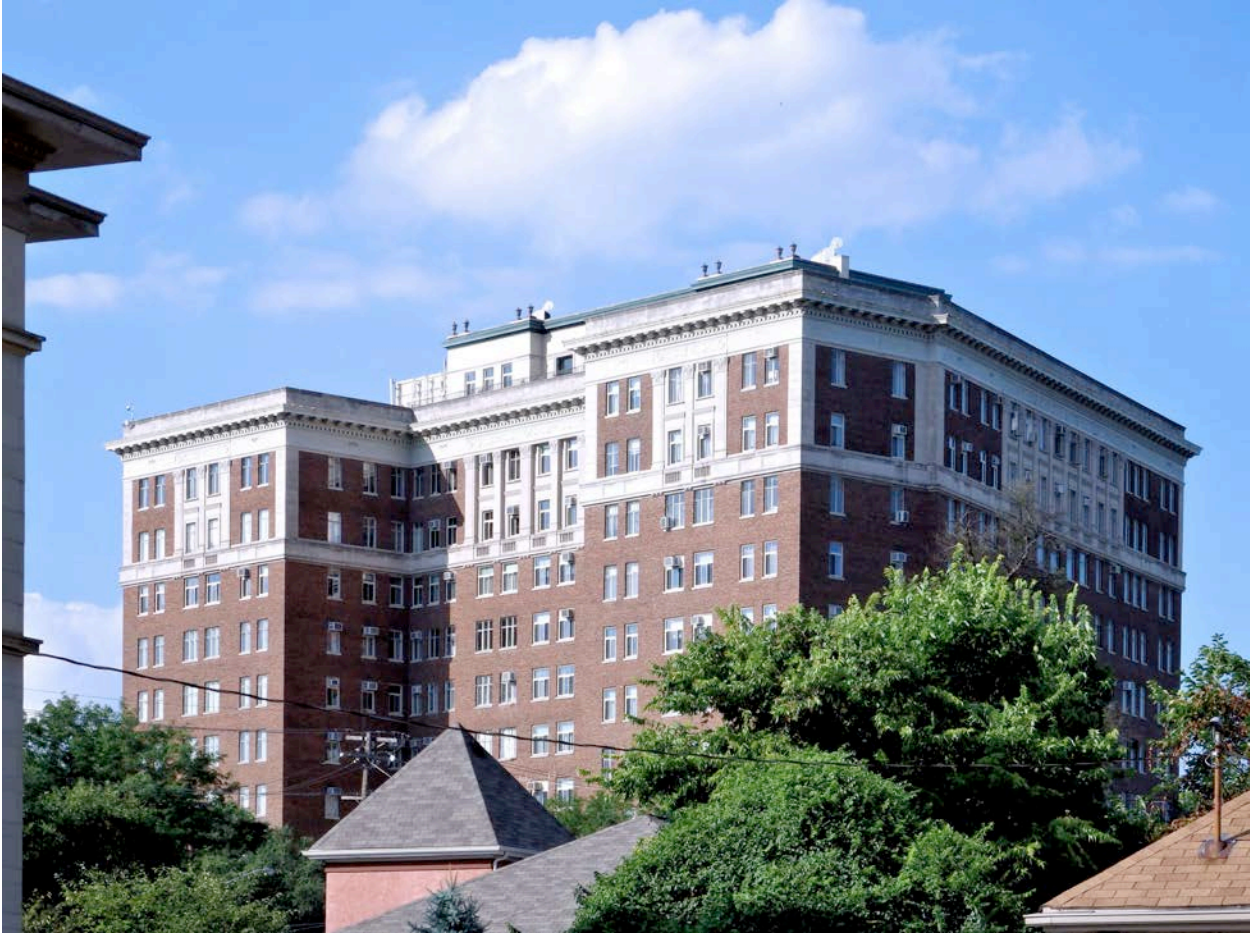
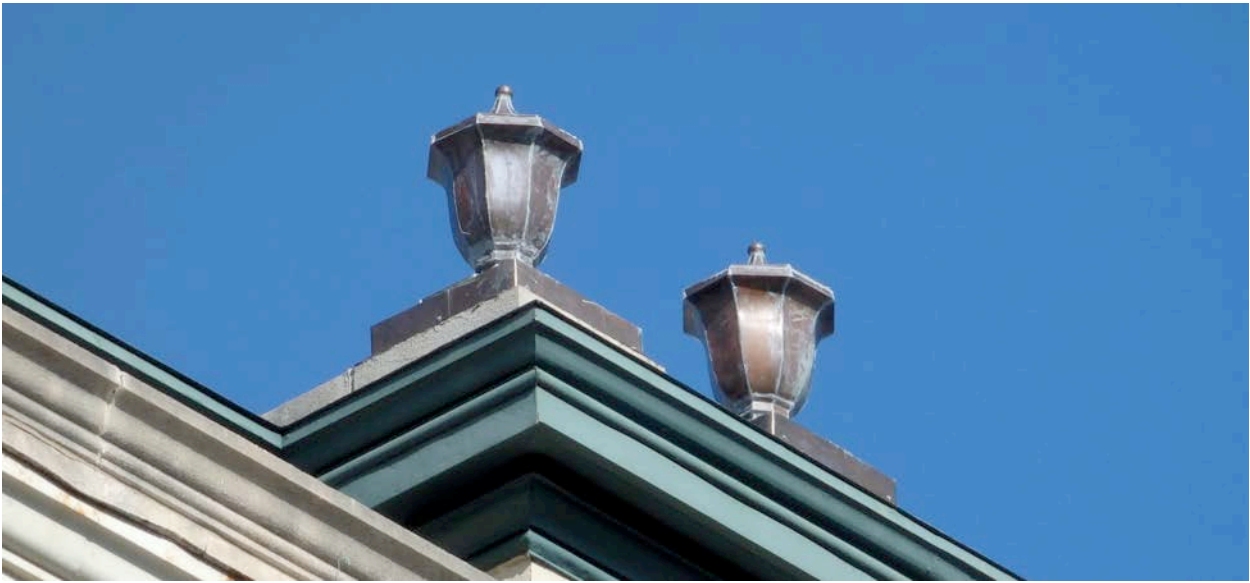
2016 – all the urns are back!
